No. 26

Air France, Boeing 707-328, F-BHSA accident at Hamburg - Fuhlsbüttel Airport, Germany, 27 July 1961. Report, dated 6 June 1963, released by the Federal Office of Aviation, Germany.

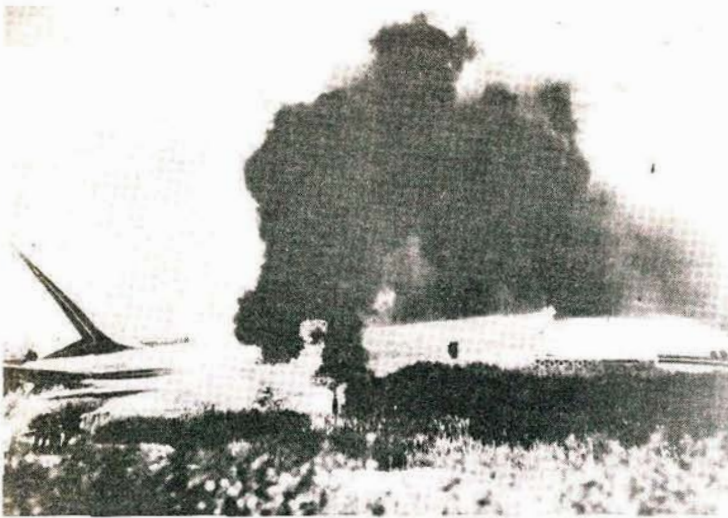
FIGURE 10

Having rolled 2 360 m, the aircraft ran off the runway in a gentle curve to the left. In turn, the nose gear assembly, the port undercarriage and finally the starboard undercarriage broke off. Finally the aircraft came to rest in a depression 1.5 m deep and 30 m wide with its fuselage broken into three parts. (See Figures 10, 11 and 12).
